**Application for Approval of a Certificate of Public Convenience and Necessity for
the A.S. Mawdsley Terminal Station Project (Application) ~ Project No. 1599424
Response to the Industrial Customers Group (ICG) Information Request (IR) No. 2**

Attachment 1.2

LTC CONDITION ASSESSMENT REPORT ASM T1 and T2 TRANSFORMER

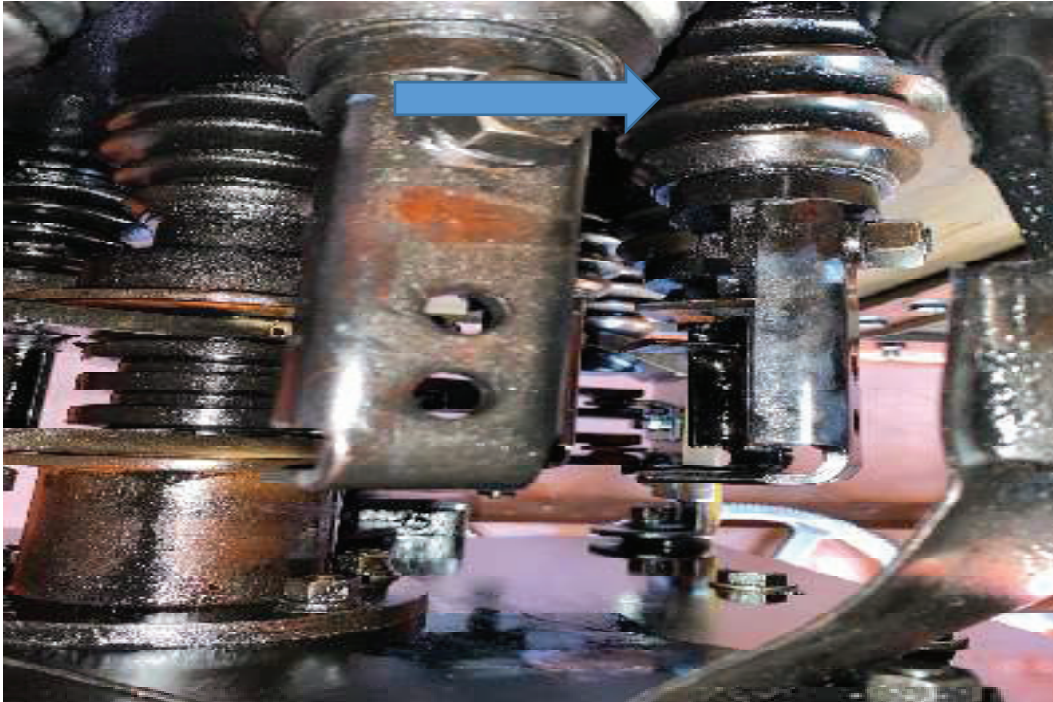
#	Assessed Component	Findings	Corrective Actions
1	Liquid Insulation Condition	Oil filtration pump was found not working. The insulating oil was heavily contaminated with carbon (see Figure 3).	The LTC tank was drained and refilled with new oil. The tank and components were properly cleaned. Oil filtration is currently working.
2	Solid Insulation Condition	Ceramic pass-through bushings were heavily contaminated with carbon deposits. The LTC insulating board had no cracks and there were no leaks.	Clean up was performed.
3	Mechanical Motion (1)	The following were inspected and found in acceptable condition: <ul style="list-style-type: none"> • Geneva gear and Geneva drive • Scroll cam • Levers • Assembly boards 	NA
	Mechanical Motion (2)	The LTC was operated without oil. It seemed to operate properly but noisy-violent. Dynamic Braking System could not be inspected (protective shroud could not be removed). No bouncing was observed but the mechanism did not stabilize immediately after the tap sequence was completed. This appears to be normal for unit with no dashpots.	NA

Figure 3 ASM T1 High Carbon Contamination

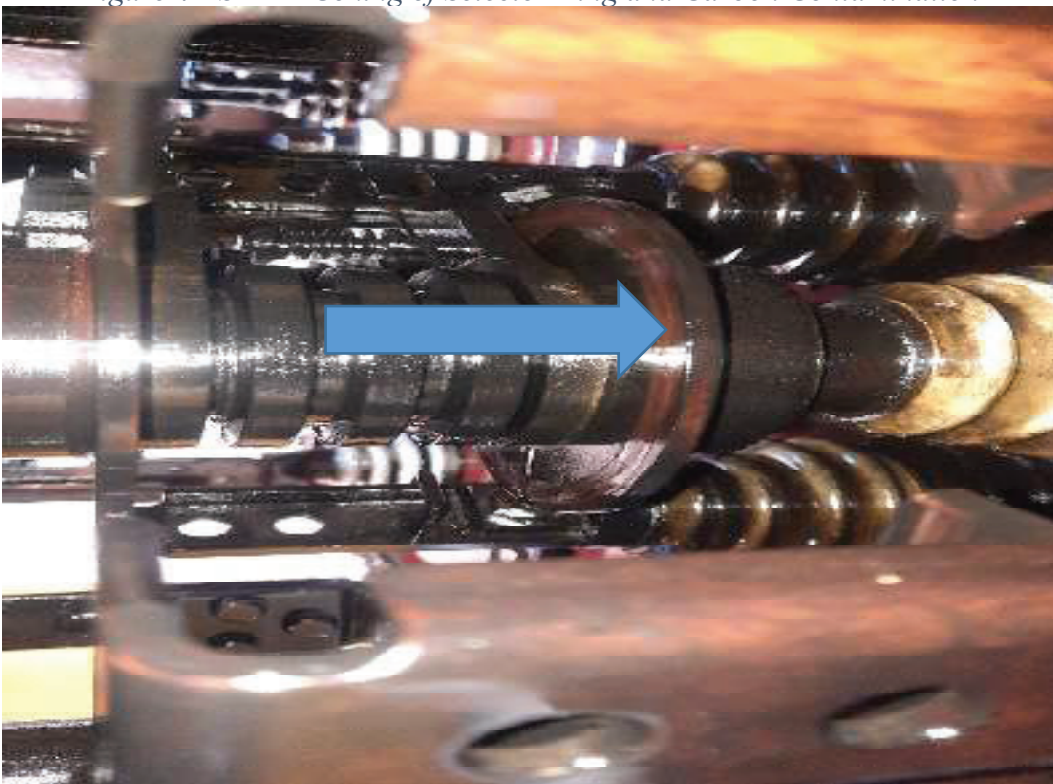
#	Assessed Component	Findings	Corrective Actions
1	Liquid Insulation Condition	Oil filtration pump was working.	The LTC tank was drained and refilled with new oil. The tank and components were properly cleaned.
2	Solid Insulation Condition	Ceramic pass-through bushings were mildly contaminated with carbon deposits. The LTC insulating board had no cracks. The ceramic pass-through bushings were in acceptable condition. There was a small leak from the main tank. Signs of flashing across were recorded on insulating push rods.	Clean up was performed. Due to the constructive type of seal and the lack of access, a proper leak mitigation could not be completed.
3	Mechanical Motion (1)	The following were inspected and found in acceptable condition: <ul style="list-style-type: none"> • Geneva gear and Geneva drive • Scroll cam • Levers • Assembly boards 	NA
	Mechanical Motion (2)	The LTC was operated without oil. It seemed to operate properly but noisy-violent. Dynamic Braking System could not be inspected (protective shroud could not be removed). No bouncing was observed but the mechanism did not stabilize immediately after the tap sequence was completed. This appears to be normal for units with no dashpots.	NA

Figure 4 ASM T2 Coking of Selector Ring and Carbon Contamination

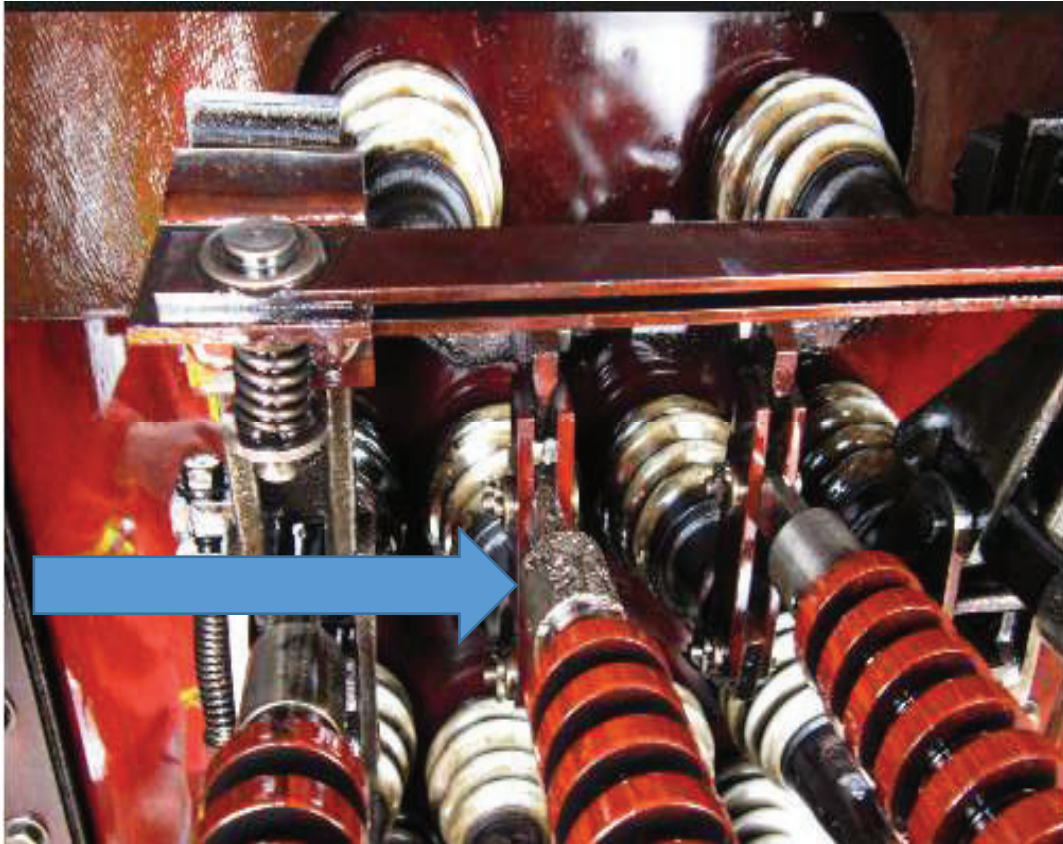
Rings and Push Rods	seem to be in good shape. There were no signs of flash over or across. There is no need for contact replacement.	
8	Reversing Switch and Contacts	The reversing switch seemed to operate properly. There were signs of pass-through operation (scratches). No coking was observed. There is no need for contact replacement.	NA
9	Diverter Contacts (1)	Diverter's main mobile and fixed contacts did not show signs of wear and did not need to be replaced.	<i>Review action plan after completing EIR-E-2023-09 "GLE T2 LR 83 LTC failure"</i>
	Diverter Contacts (2)	Diverter's arcing contacts were found heavily pitted. In-service contacts are reverse engineered after market parts and do not pair off properly (angled, not flat). This explains DGA results and the assumption of violent-uncontrolled arcing (see Figure 5)	Only cleaning was completed. In 2-3 years, all arcing contacts should be replaced.

Figure 5 ASM T2 Signs of uncontrolled arcing

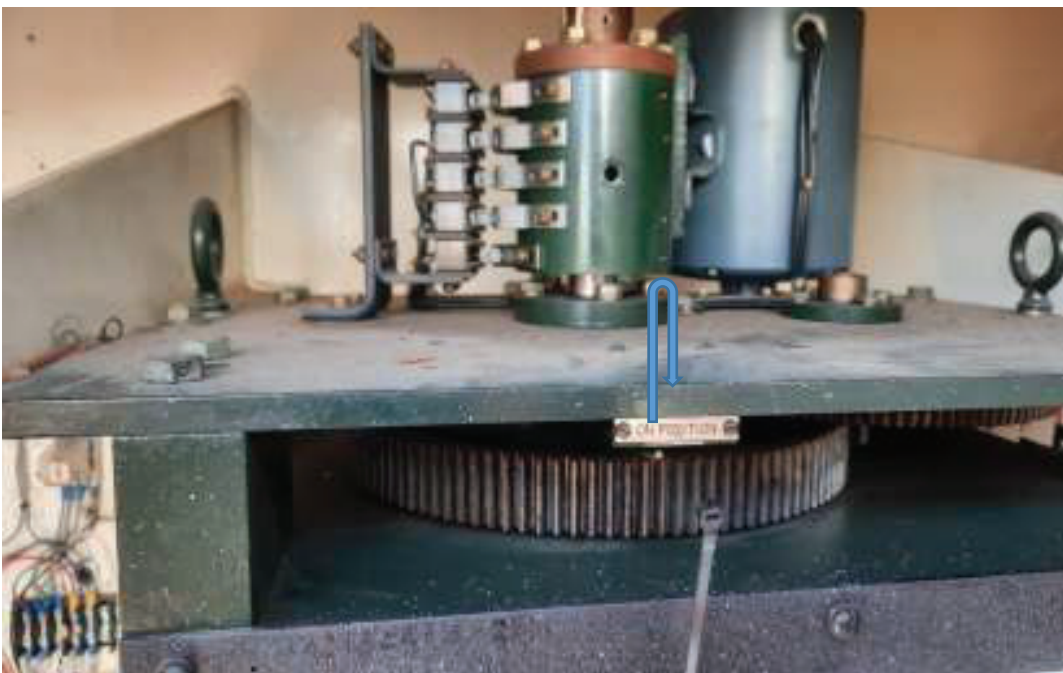
4	Synchronization	The three LTC heads seem to operate in perfect synchronism and the sequence of operation was as expected. A misalignment was observed in the operating gear and that might be caused by operating gear wear (see Figure 6).	Investigate further.
5	Critical Measurements	Due to the age of the compression springs, a jig saw pattern was recorded during electric resistance measurement (see Figure 7). This is a sign of non-uniform/reduced contact pressure.	User manual is not available. Measurements and adjustments could not be performed. Manually actuating each contact was the only option.
6	Tap and Stud Contacts	Based on visual inspection only, contacts seem to be in good shape and there is not need for immediate replacement. Some moderate contact coking was observed (see Figure 4).	Due to the lack of spare compression springs, dismantling was not attempted. Slide contacts were cleaned by operating the LTC.

Figure 6 ASM T2 Misalignment of the gear mechanism

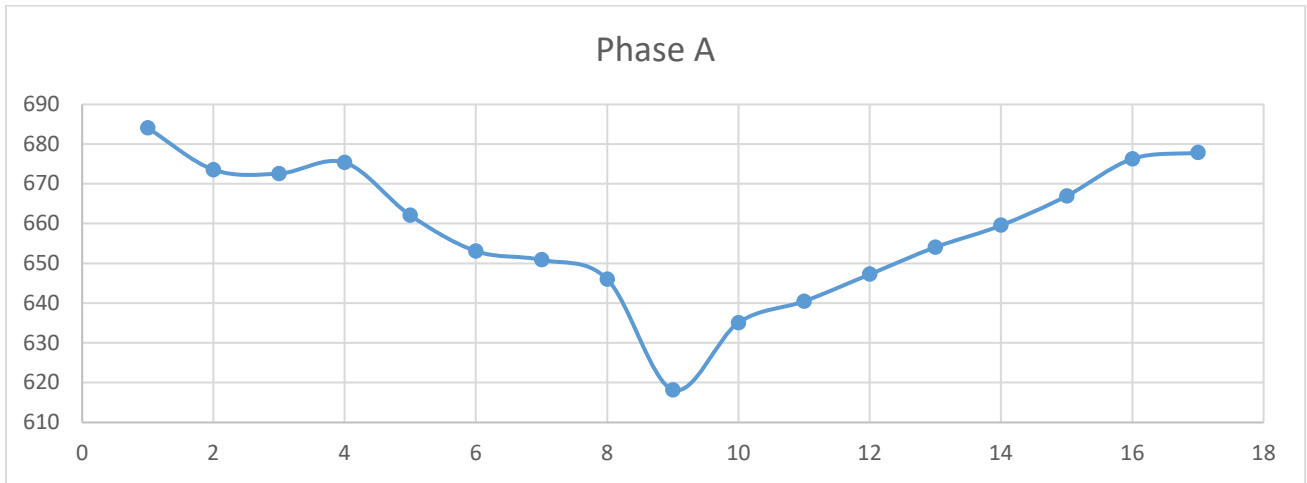
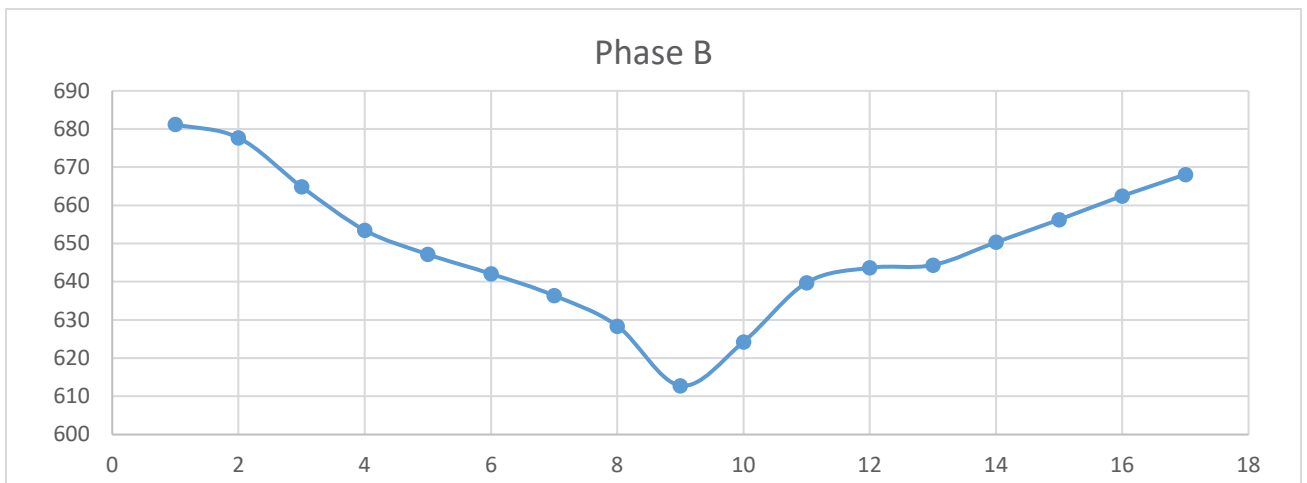
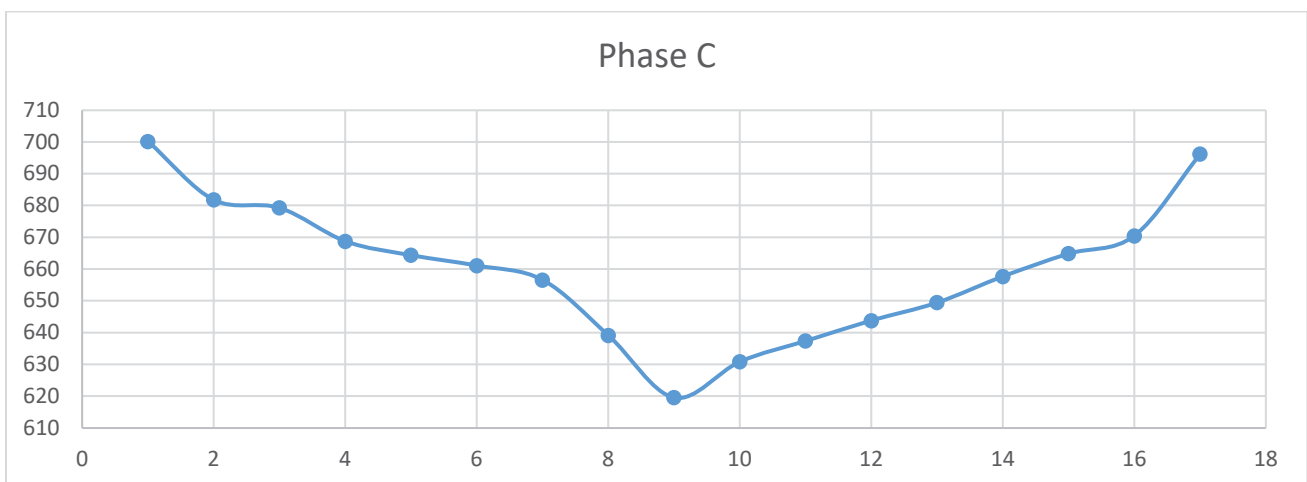
10	Auxiliary Contacts	The auxiliary contacts were visually inspected and are in ok condition.	Contacts were cleaned with spray on contact cleaner.
11	Motor Drive	Measured inrush and operating currents did not indicate any problems.	LTC motor is not making use of starting capacitors. The centrifugal switches could not be assessed.
12	Tap Counter	The tap counter seemed to operate properly.	NA
13	Dynamic Performance	Some anomalies have been recorded. See Figure 7 indicating fluctuating tap to tap resistance.	Reschedule testing for 2024.

Figure 7 ASM T2 Winding Resistance (LTC side)
