**Re: FortisBC Inc. (FBC)**

**Application for a Certificate of Public Convenience and Necessity (CPCN) for the Grand Forks Terminal Station Reliability Project (the Application)**

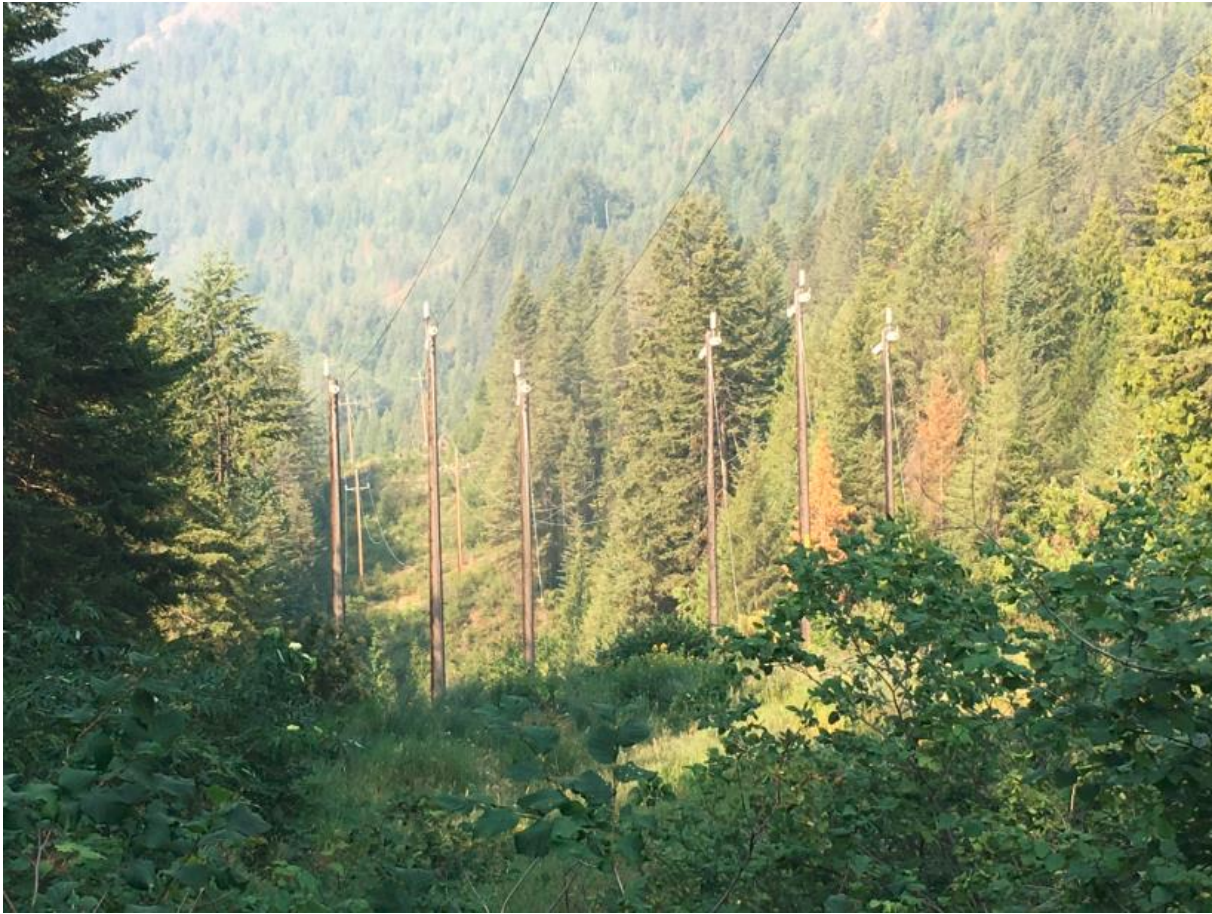
**Figure 3-4: 9L and 10L Rossland Mountain Range Terrain**

3 Given the extremely poor condition of 10L, it is normally de-energized between the CHR tap and  
4 CSC substation. The line must be visually assessed and rehabilitated to minimum operating  
5 standards before it can be energized in the event of an emergency. In winter this can be nearly  
6 impossible, as 10L cannot be accessed from the ground due to the snowy and mountainous  
7 terrain.

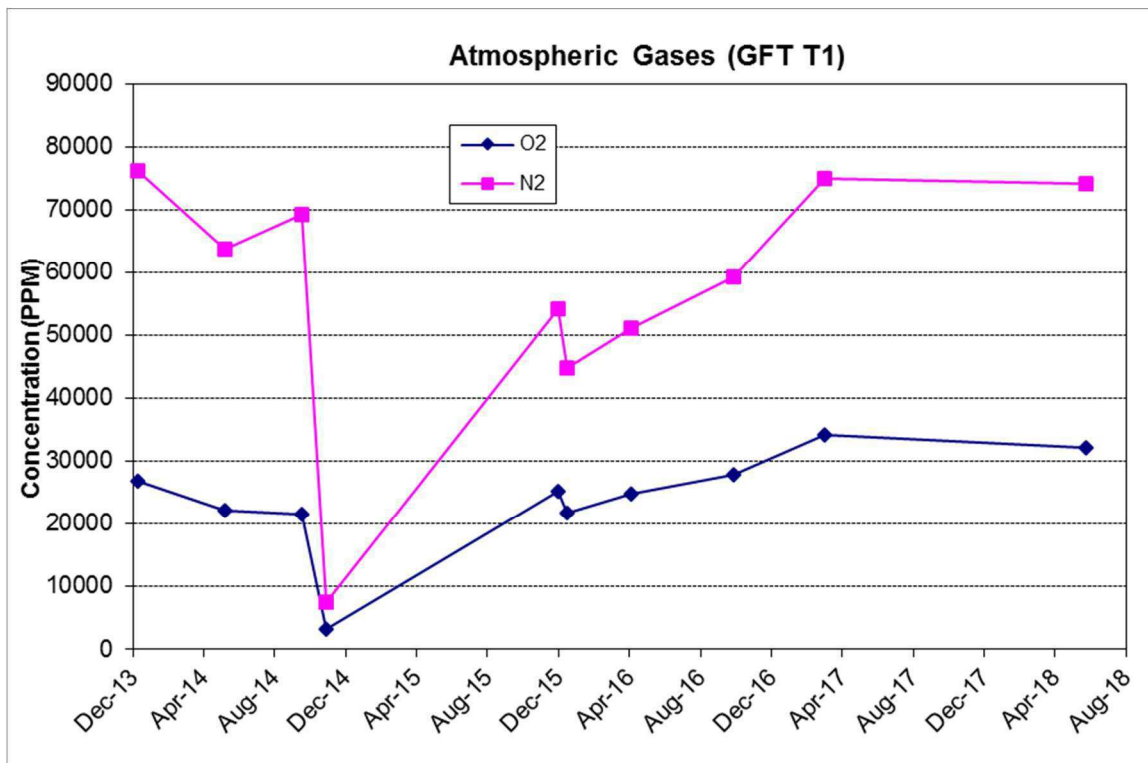
**Fig 3:** Atmospheric gases

### 3.3. Atmospheric Gases

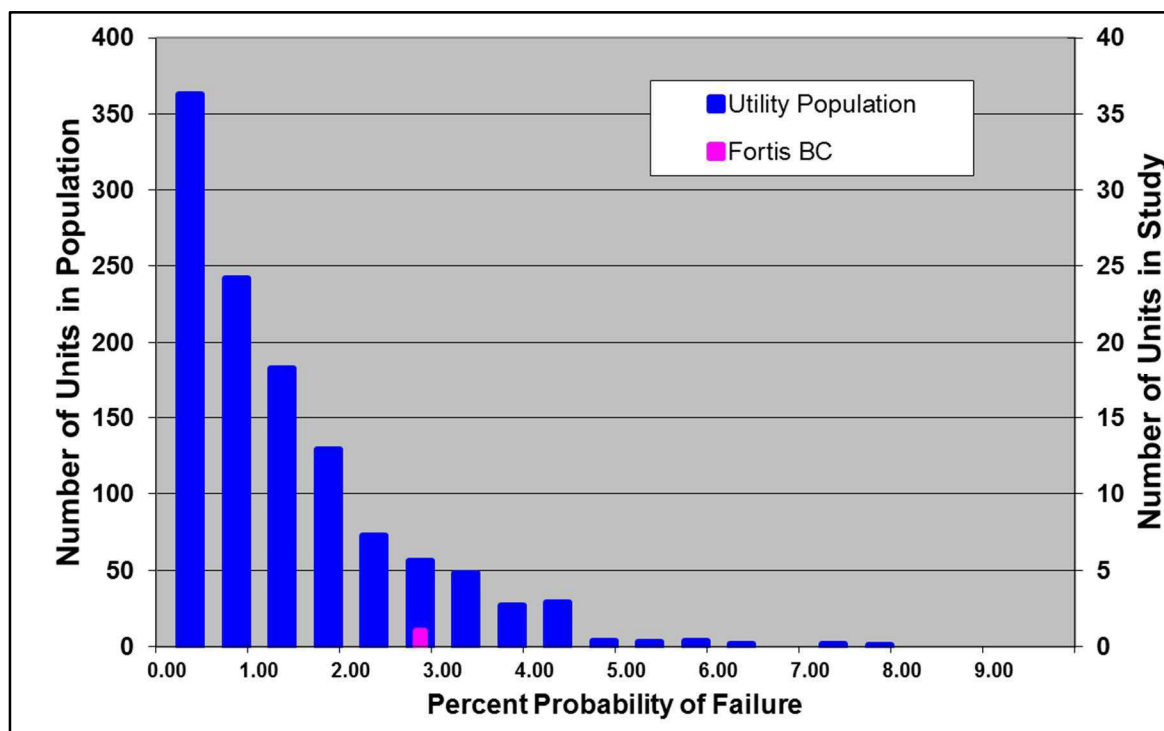
The results above indicate a high risk of failure (2.6) for this transformer based on the current DGA in oil and available test and maintenance data. The below figure shows the Risk of Failure (RoF) compared to a transmission utility population. It can be seen that RoF is on the high side for this unit.

**Figure 6 – Risk of Failure Compared to a Transmission Utility**

The condition assessment calculated the Risk of Failure (RoF) for this transformer to be 2.6 percent based on the most recent DGA and the available test/maintenance data.<sup>10</sup> The RoF for this unit is on the high side when compared to a typical utility population.

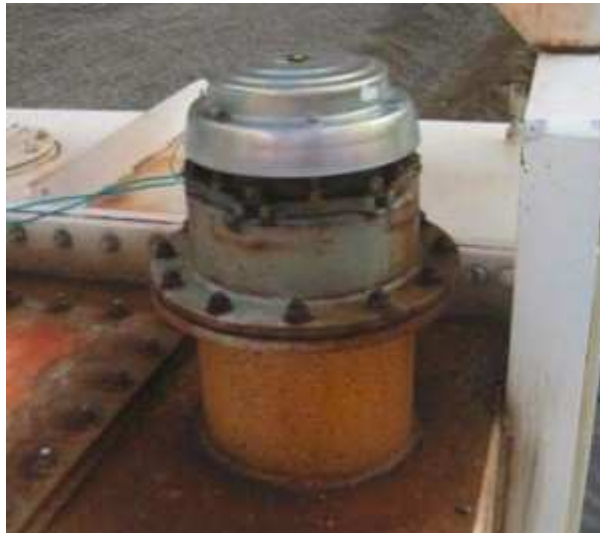
The main tank shows normal signs of wear, paint oxidation and surface corrosion. Three oil leaks were identified, two of these are shown in figures 1 and 2; they include the main tank pressure relief device and thermal well plate respectively. The third oil leak is located at the core ground terminal; an oil leak was made visible when the core ground cover was loosened to access the terminal for testing, the cover was not removed to prevent further oil leak. Two core ground terminal covers are located on top of the transformer, both found with similar problem.

**Figure 1: Main tank pressure relief device, the debris below the device is evidence of an oil leak**

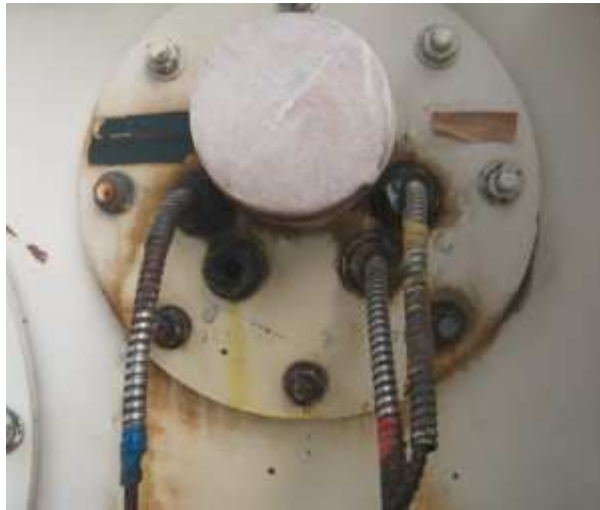
**Figure 2: Signs of an oil leak on the side of transformer tank are visible stemming from the thermal**

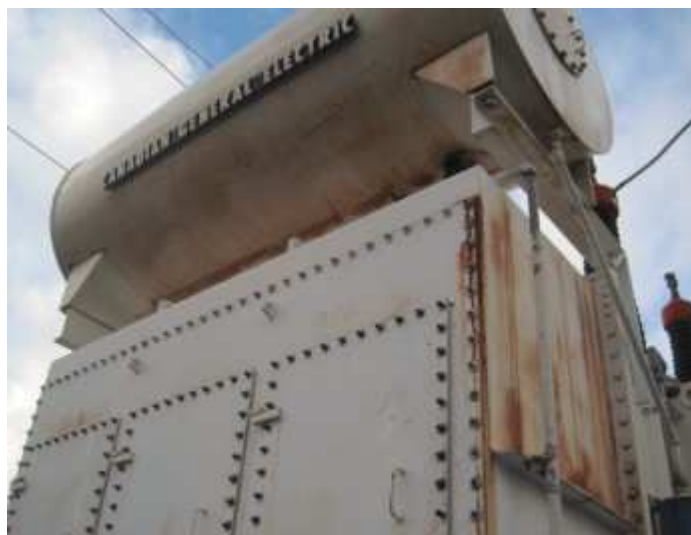
**Figure 3: Tap changer compartment and conservator showing surface corrosion**

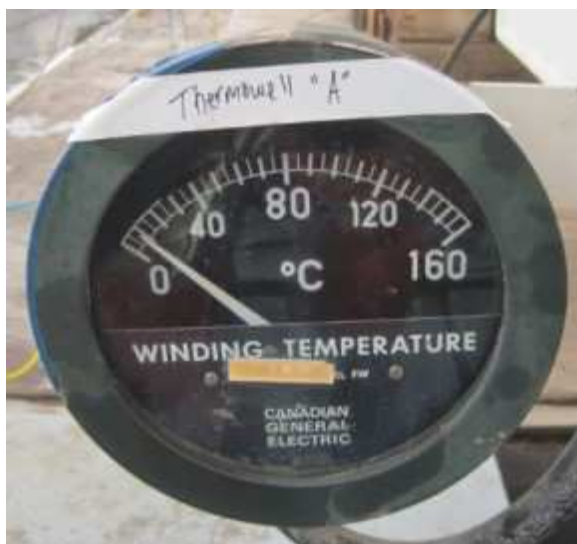
The transformer is equipped with four temperature gauges, conservator and tap changer level gauges and one gas detector relay. All devices were inspected and function tested. The tertiary winding temperature gauge labeled 13kV shown in figure 4 was found to have faulty contacts.

**Figure 4: The Model FW temperature gauge contains a faulty contact used for fan control**

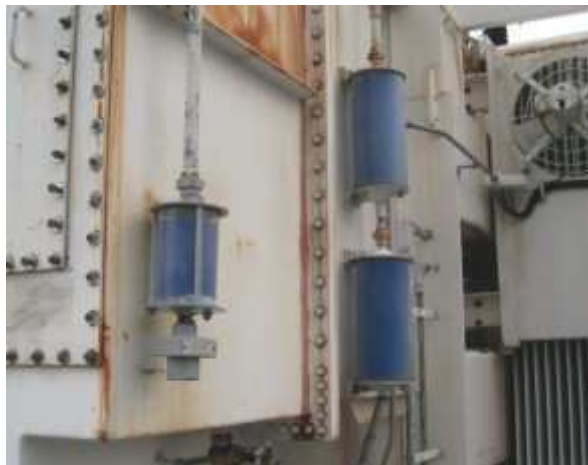
Both the tap changer and main tank conservators breathe through a moisture absorbing desiccant located near the bottom of the transformer. The old desiccant was removed and replaced with new blue desiccant. The desiccant columns shown in figure 5 appear to be in good condition.

**Figure 5: Desiccant columns shown with new desiccant installed**
