**Application for Approval of a Certificate of Public Convenience and Necessity for
the A.S. Mawdsley Terminal Station Project (Application) ~ Project No. 1599424
Response to the Industrial Customers Group (ICG) Information Request (IR) No. 2**

Attachment 1.2

LTC CONDITION ASSESSMENT REPORT ASM T1 and T2 TRANSFORMER

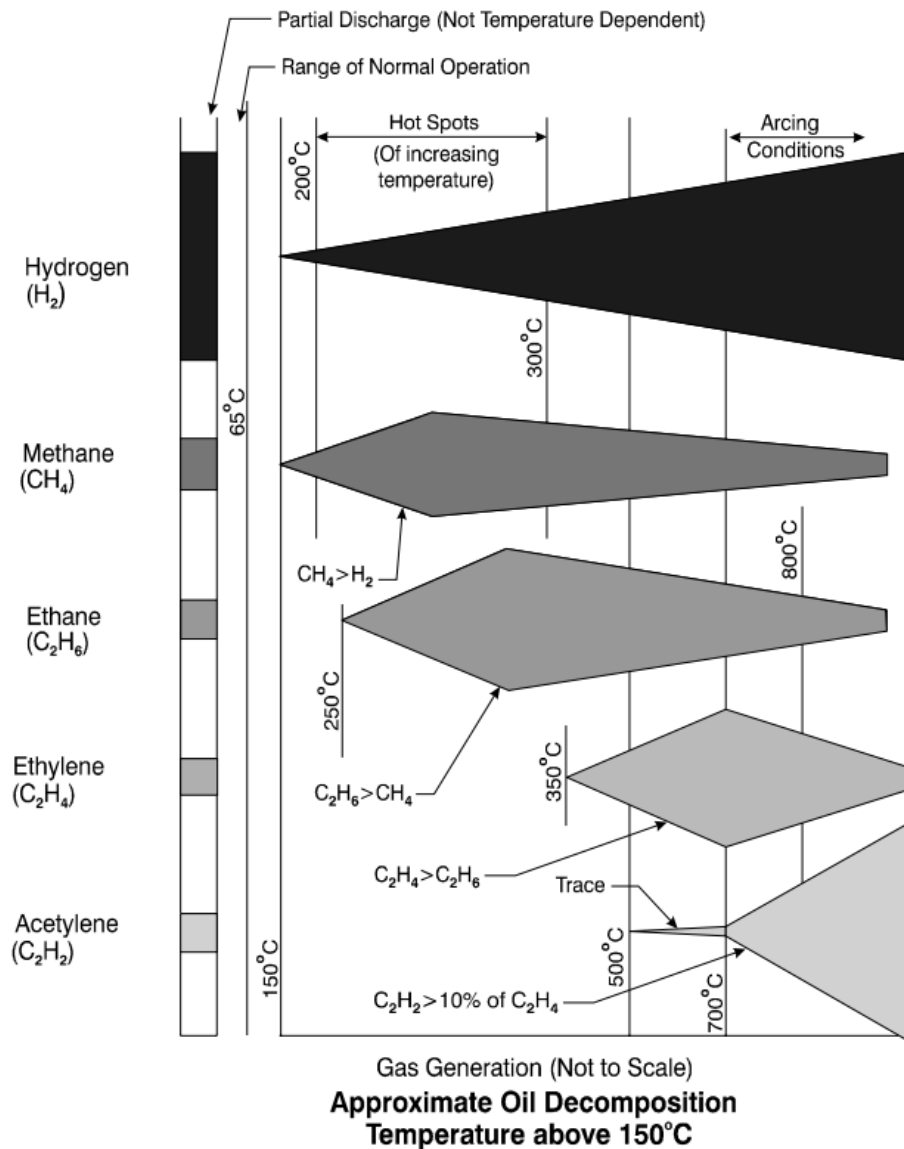
9 Certain fault gases are produced more frequently in transformer oil as fault temperature
10 increases. Please refer to the figure below from the US Bureau of Reclamation brochure “FIST 3-
11 30 Transformer Maintenance” which indicates that acetylene is mainly produced during arcing.
